October Monthly Report for the Falls Creek Hydro-electric Project  
FERC # P-11659

**Falls Creek Hydroelectric Project (P-11659)**  
**MONTHLY CONSTRUCTION REPORT TO FERC**  
**October 2006**

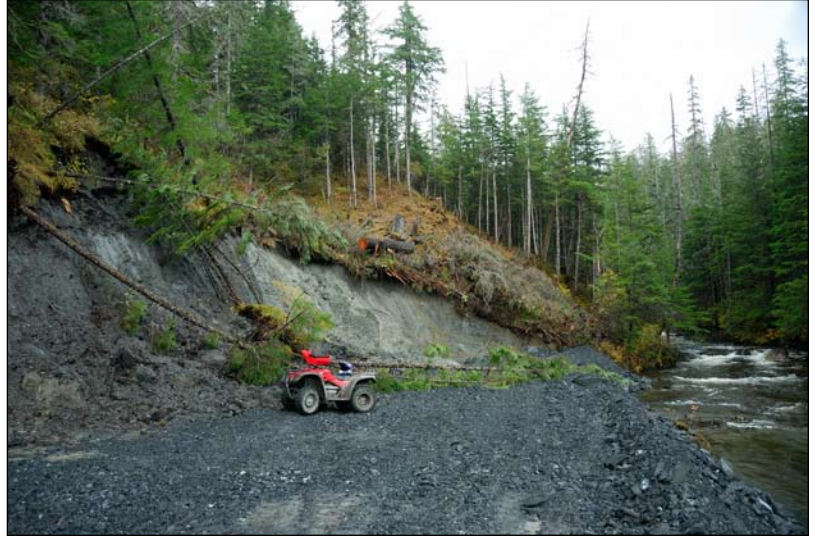
*The terminus of the Intake Service Road.*

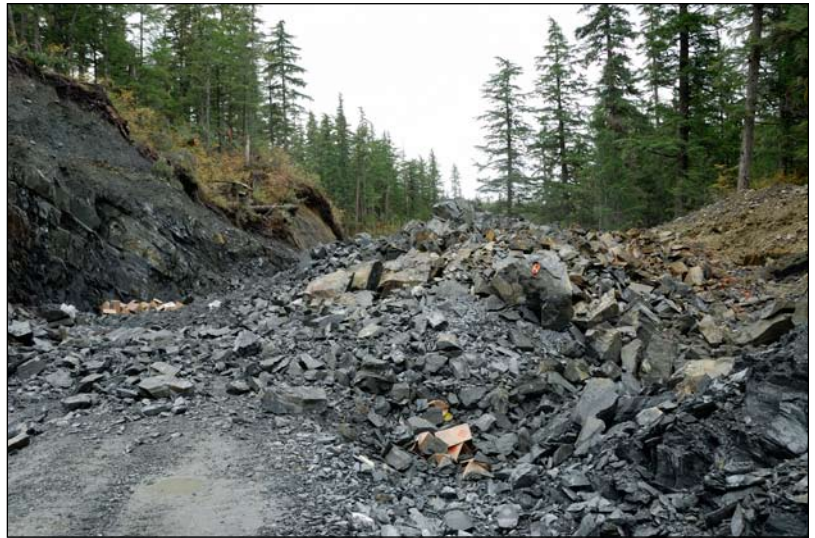
*The scene at the Blueberry Hill Road Cut immediately following the October 6th shot.*

On October 6th, a shot at the upper end of the Blueberry Hill Road Cut resulted in a slide which reached the creek.

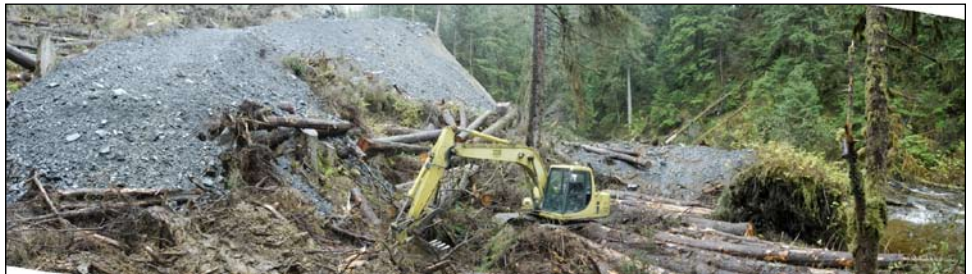
*This picture was taken while standing at the approximate location of the future powerhouse - looking upstream and up the newly constructed powerhouse service road. The October 19th rock, mud and debris slide covers the stream just behind the small track hoe.*

Drilling continued on the powerhouse road on October 9th and a slide occurred on October 12th. Drilling and shooting alternated between the powerhouse area and the intake area, with a large slide occurring October 19th in the powerhouse area and a small slide occurring at the intake area on October 22nd.

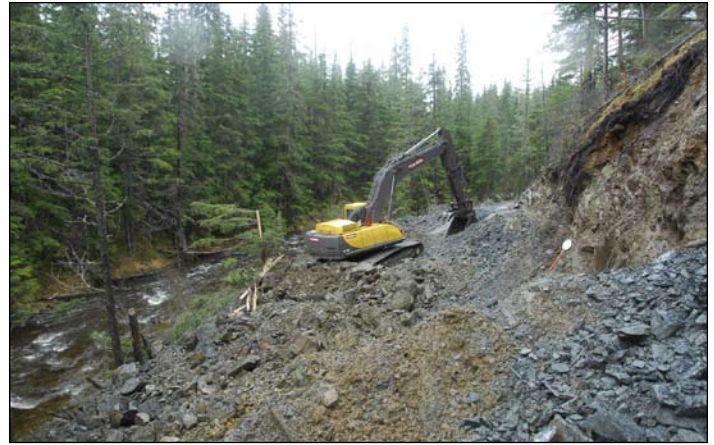
*This picture was taken approximately half way up the Intake Service Road. Here, the first phase of the constructed road is being drilled, blasted and widened to better accommodate the plan to put the HDPE pipe on the creek side of the road.*

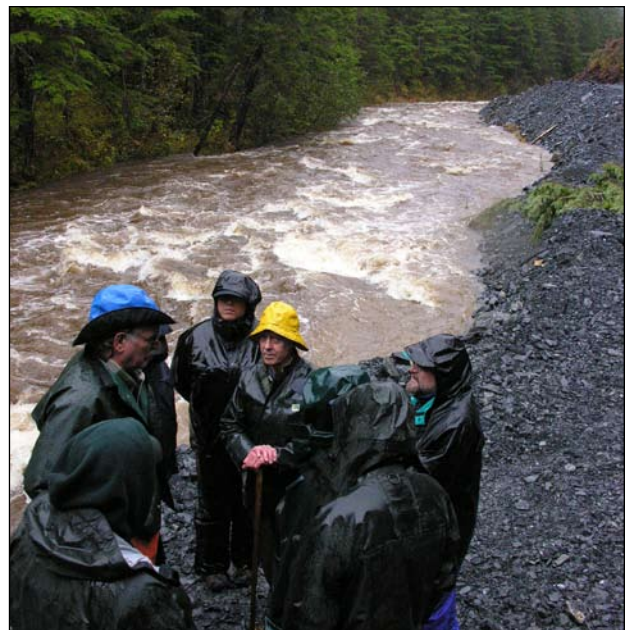
*Dick Levitt meeting with agency personnel at the future impoundment site. Turbidity "naturally" high on this rainy day.*

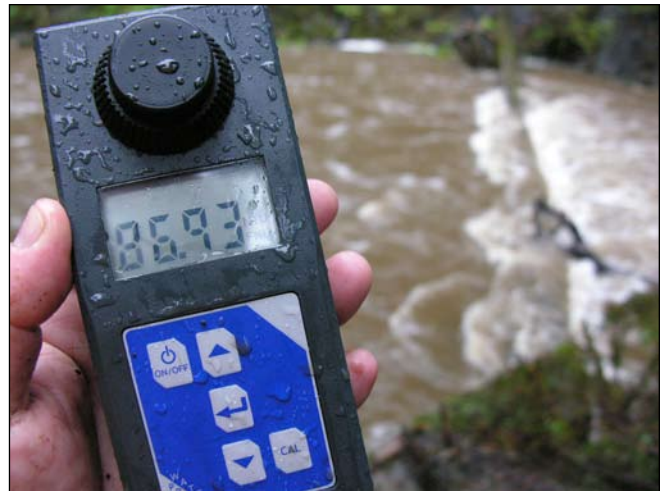
*High turbidity due to a combination of on site construction and flood stage conditions.*

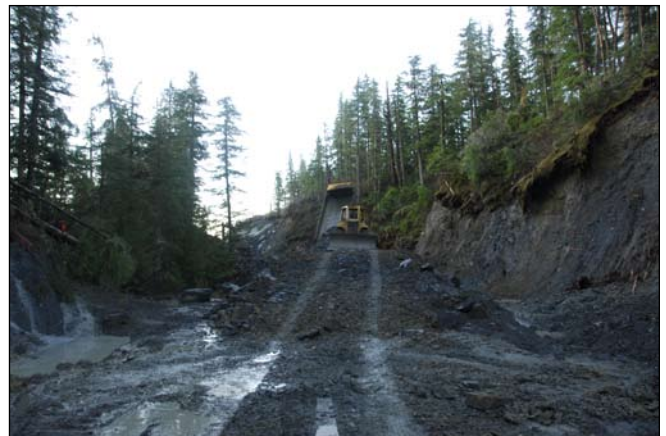
Other than the slides created this month by construction activities, most earth-work in general has resulted in little increase in stream turbidity. The situation at the horse shoe ridge was dramatically improved over last month when the road was lifted approximately 8 feet. This provided increased catchment on the uphill side of the road with a deep ditch and removed most of the potential for road runoff to transport sediments to the slopes and creek below.

*"Lifting" of the road through the Horse Shoe Ridge Cut greatly improved sediment control here. New road surface is at approximate elevation of the bottom of the penstock ditch.*

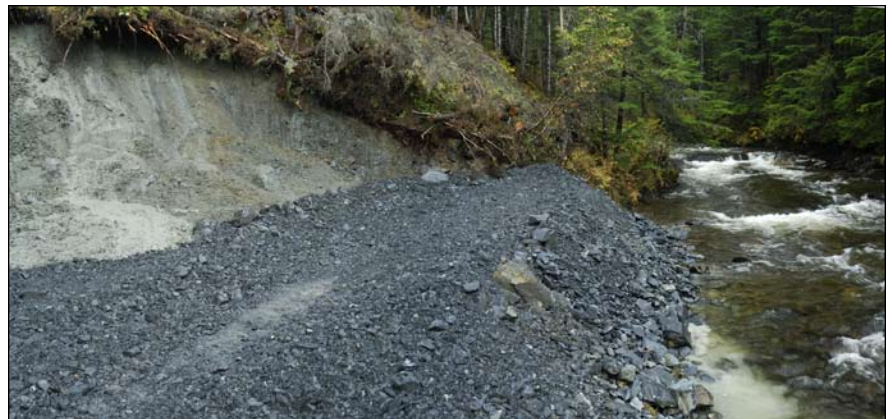
A few silt sources continued to slightly increase turbidity along the Intake Service Road (~ + 5-10 NTUs). Proper ditching and culverting of the final road should easily control most sources. The obvious exception is the intake site. The current plan calls for several thousand yards of excavation work immediately above the intake site. This slope appears to be overlain by deep layers of lodgement till and weathered clays. Blasting is also scheduled for this area. Geotechnical surveys and specific engineering and construction plans designed to address long-term slope stability and erosion issues are important to address Environmental concern here.

*This is the location of the future impoundment site. Additional cutting and blasting of the slope is scheduled to prep the site for impoundment construction. Note the weeping clays coming off the slopes and seeping through the road into the creek.*

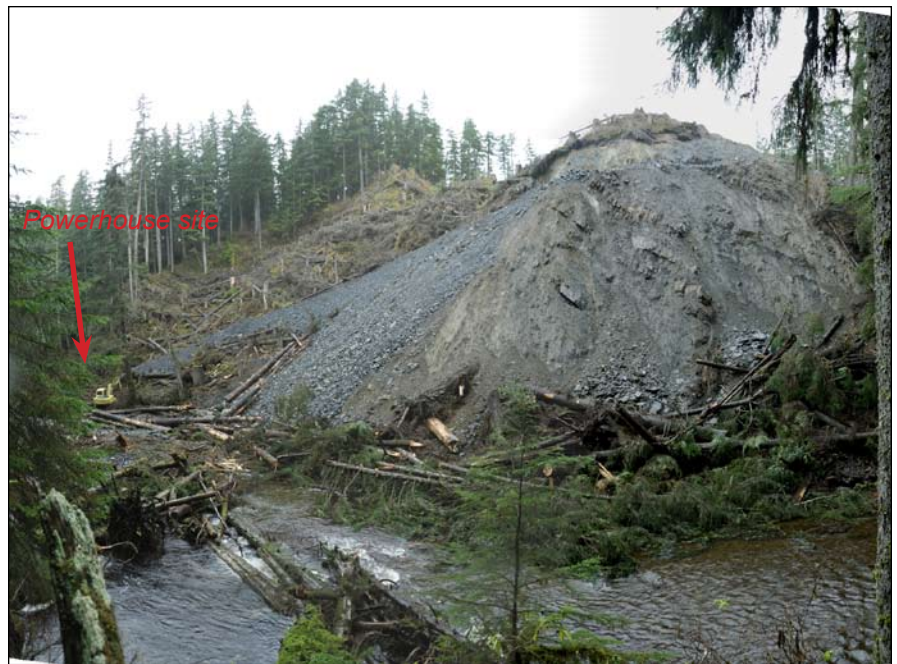
Blasting this month resulted in 4 slides into Falls Creek. The first slide occurred on October 6th and the fourth slide occurred on October 22nd. The slides have had minimal-moderate immediate impacts on fish habitat, however, slope instability and the threat of further mass wasting is a serious concern in all areas, including blasting areas scheduled for the near future. Two of the slides at the powerhouse area had direct impacts to anadromous fish habitat that may necessitate mitigation. Each of the 4 slides occurred as a result of bedrock blasting for service road construction along the steep slopes of the Falls Creek Canyon. For further details please refer to the Record of Concern submitted to FERC on October 27.

*Profile view of the powerhouse service road. Although a small slide existed here prior to blasting, most of the material slid following blasting of the road cut - four constructed related slides in total here.*

The October slides have served to heighten our awareness of slope instability along the Falls Creek canyon, especially in the vicinity of the powerhouse and anadromous reaches. In light of this information the ECM and project Manager are consulting with DNR and ADF&G personnel on a plan that would include mitigation of damaged habitat for slides to date, as well as possible changes to the tailrace design. A change in the tailrace design would necessitate a **modification of the Final Environmental Design Plan**. A plan for mitigation of current and potential future impacts to fish habitat and slope stability will be drafted by December and a meeting scheduled with all relevant agencies as soon as possible so that adequate time for feedback and approval

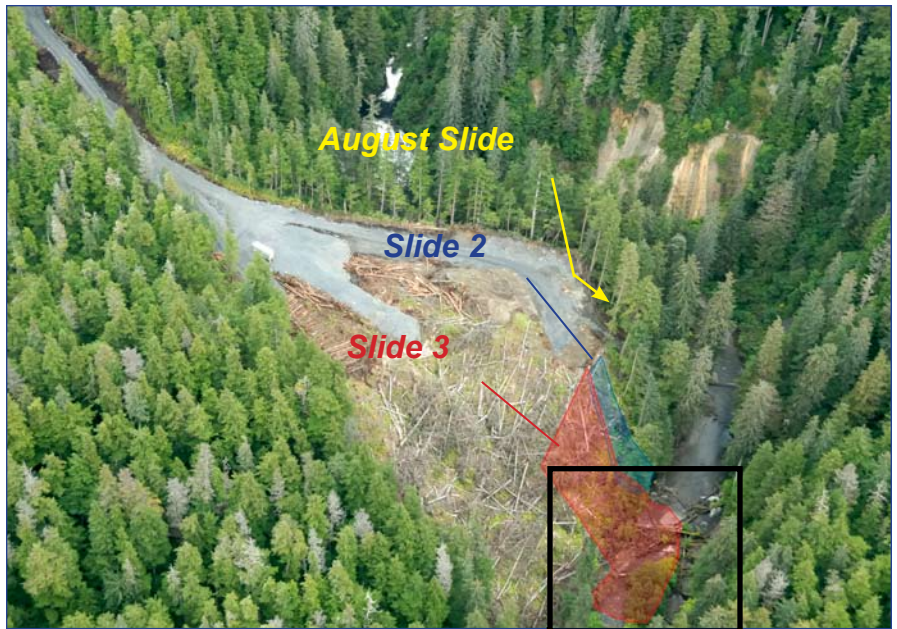
*Above - Figure 4.0 from the October 27 Record of Concern: Aerial view of the powerhouse area that shows the August slide and the locations impacted by slide 2 and slide 3.*

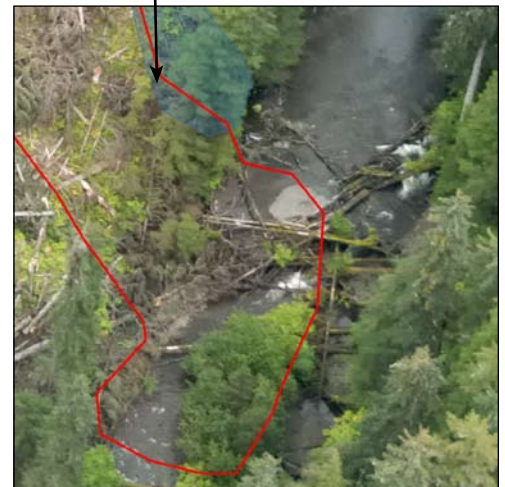
*Right - crop of above showing that a primary channel was covered by the slide, including potential spawning gravels.*

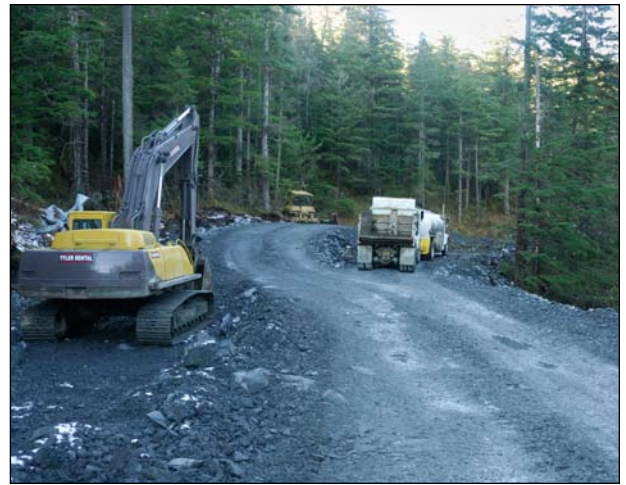
*Just up stream of the Horse Shoe Cut the Intake Service Road becomes 1.5 "lanes". The lower road is the bed for the penstock, the upper road is for the service road.*

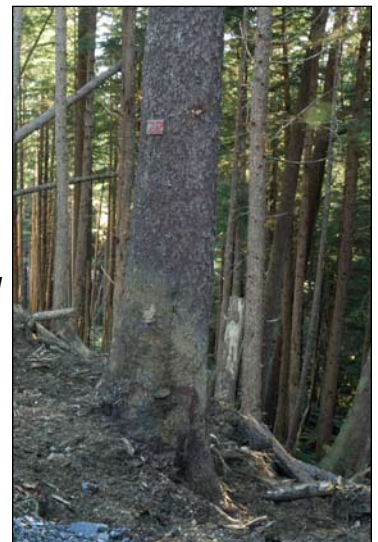
A marbled murrelet tree identified as impacted in the July 12 Non-conformance report was excavated in October. Though the tree suffered scarring during the filling and excavation it is likely that it will survive the impact of being buried in fill for 3 months if roots have not been damaged.

*Potential Marbled Murrelet tree that had been buried during road construction in July was excavated this month in fulfillment of a commitment made in a Non-conformance report.*
